# THE UNIVERSITY of TENNESSEE SPACE INSTITUTE

Investigations into the
Mechanisms of Thermal
Cycling Damage in
Metal Matrix Composites
December, 1976

N00014-75-C-0352 NR 031-760

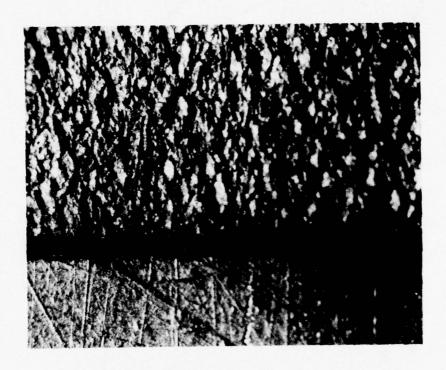
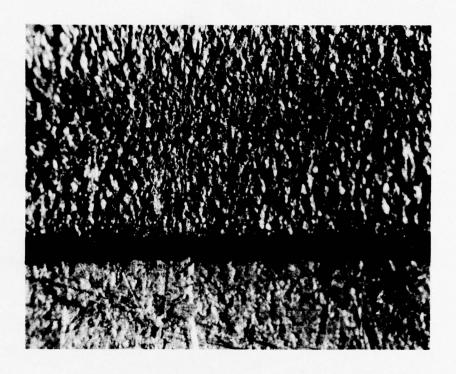
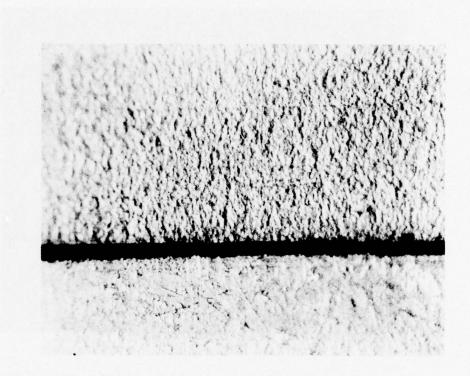
Therefore, no decrease in strength was found when B-Al was thermally cycled between -100°c and 275°c. Figures (13), (14), and (15) are photographs of the surface appearances of the three types of specimens before cycling and after 3000 cycles.

Significant surface roughening but very little cracking was observed. The 27 v/o material showed the greatest degree of roughening, presumedly because of the thicker Al surface layers.

Figure 13. Surface appearance before and after low temperature cycling of 27 v/o, 0.04 thick 6061 A1-B.

Figure 14. Surface appearance before and after low temperature cycling of 45 v/o, 0.045 thick 6061 Al-B.

Figure 15. Surface appearance before and after low temperature cycling of 45 v/o, 0.08 thick 6061 A1-B.

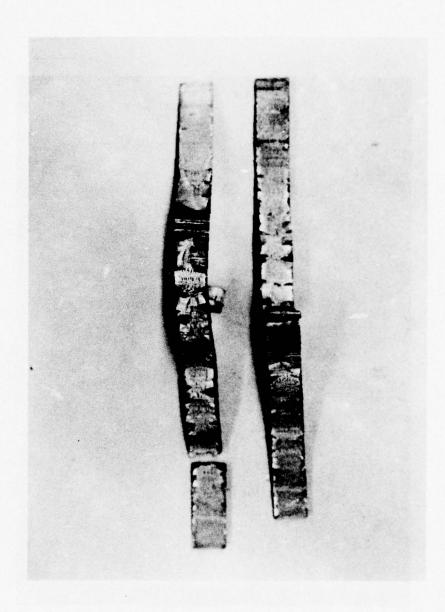
Table 9 contains results obtained from specimens cut from a panel of 0.72 inch thick carbon-2024 aluminum. This panel had very low transverse properties before cycling. Transverse specimens could not withstand an appreciable number of thermal cycles for they fell apart after only 500 thermal cycles, see Figure (16). The specimens cycled to 425°c suffered a large longitudinal strength decrease. The higher temperature specimens exhibited a surface roughening and cracking that was even more severe than that associated with the surface of specimens of boron-aluminum. This can be seen in Figure (17) where surface cracks large enough for the fibers to be seen were developed.

Figure 16. Thermally cycled transverse carbon-2024 aluminum specimens.

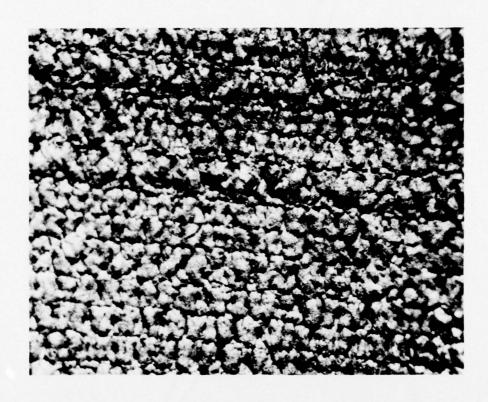
a) Matrix Degradation. Thermal cycling of aluminum matrix composites in air produces surface roughening and cracking as shown in Figure (25). For boron-aluminum, significant roughening occurs after approximately a thousand or so thermal cycles using maximum cycle temperatures above about 400°c. The extent of roughening increases with increasing number of cycles until visible cracks are evident. The cracks usually appear to start at the valleys between surface layer fibers. Later, transverse cracks develop from valley to valley across the fiber ridges. This process is depicted in the sketch of Figure (26). After a larger number of cycles, the matrix surface material inside areas outlined by the cracks tends to ball-up or form nodules as seen in Figure (27). Sometimes fibers are exposed between these nodules.

Figure 25. Surface roughening and cracking of B-Al thermally cycled in air.

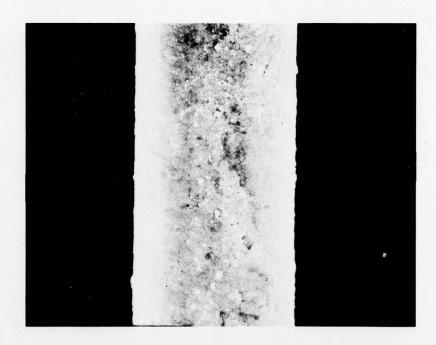
The purpose of the second SEM study was to compare the relative amounts of reaction product on extracted boron fibers. If fiber oxidation occurred in air, then more reaction material would be expected on the air cycled fibers. No conclusive trend, however, was apparent. Due to the non-uniform distribution of the reaction products, it was concluded that quite a large number of fibers would have to be examined to positively determine correlations between visible fiber degradation and thermal cycling conditions or measured strength.

Figure 29. Reaction products on a boron fiber extracted after thermal cycling.
